Re: Homesite Insurance Company v. Norcold, Inc., et al.
Loss Location: 12312 127th Ave NE, Lake Stevens, WA 98258
Date of Loss: January 29, 2021
JH File No.: 1A0461291

EXPERT DISCLOSURE REPORT

**ENCOMPASS INSURANCE COMPANY
V.
NORCOLD, INC.**

**JENSEN HUGHES FILE NO. 1A0461291
DATE OF LOSS: JANUARY 29, 2021**

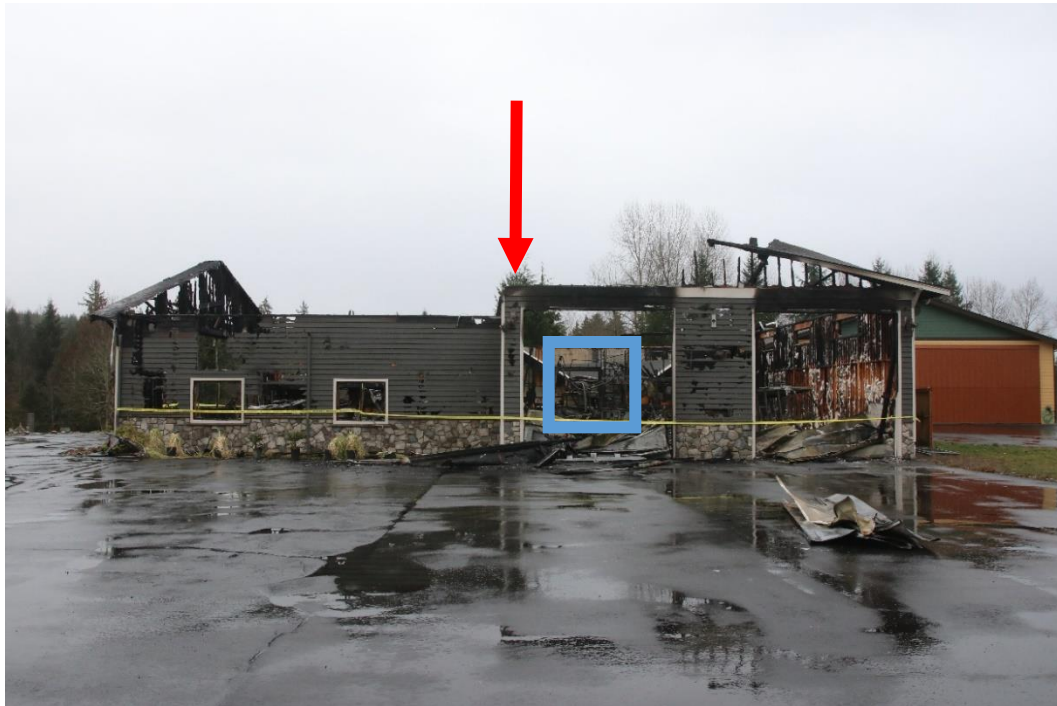
Photograph 1. 01-30-2021 SLR, IMG_0003: West exposure of the structure. Arrow indicating the general area of origin. Blue box indicates the motorcoach location.

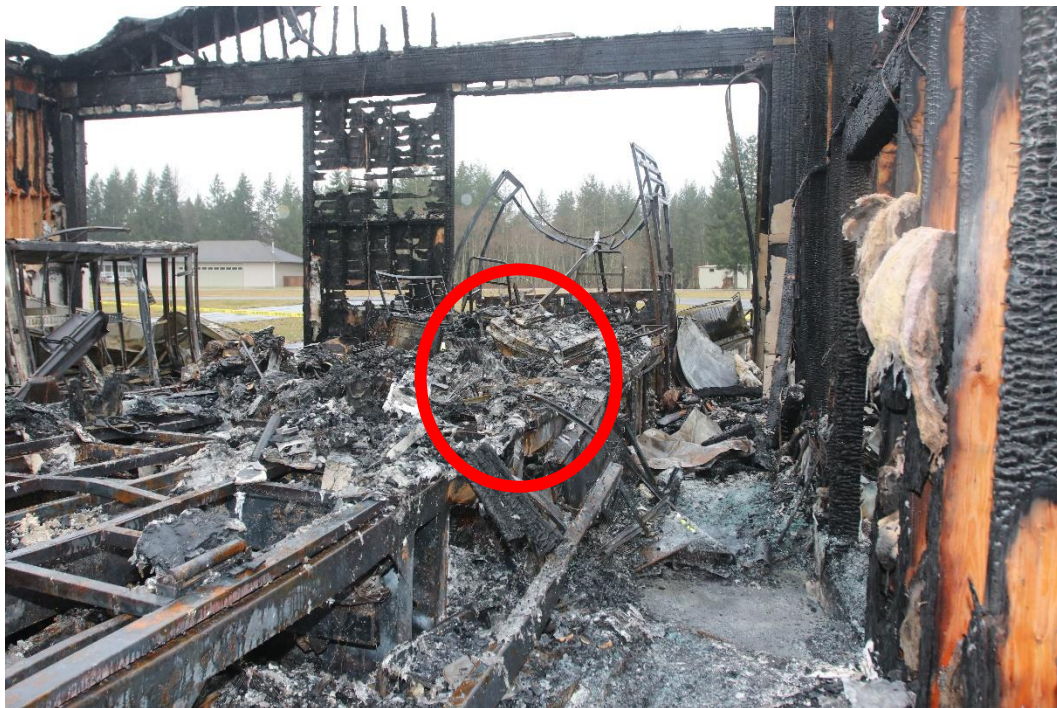
Photograph 2. 01-30-2021 SLR, IMG_0132: North (passenger) side of the motorhome and area of origin.

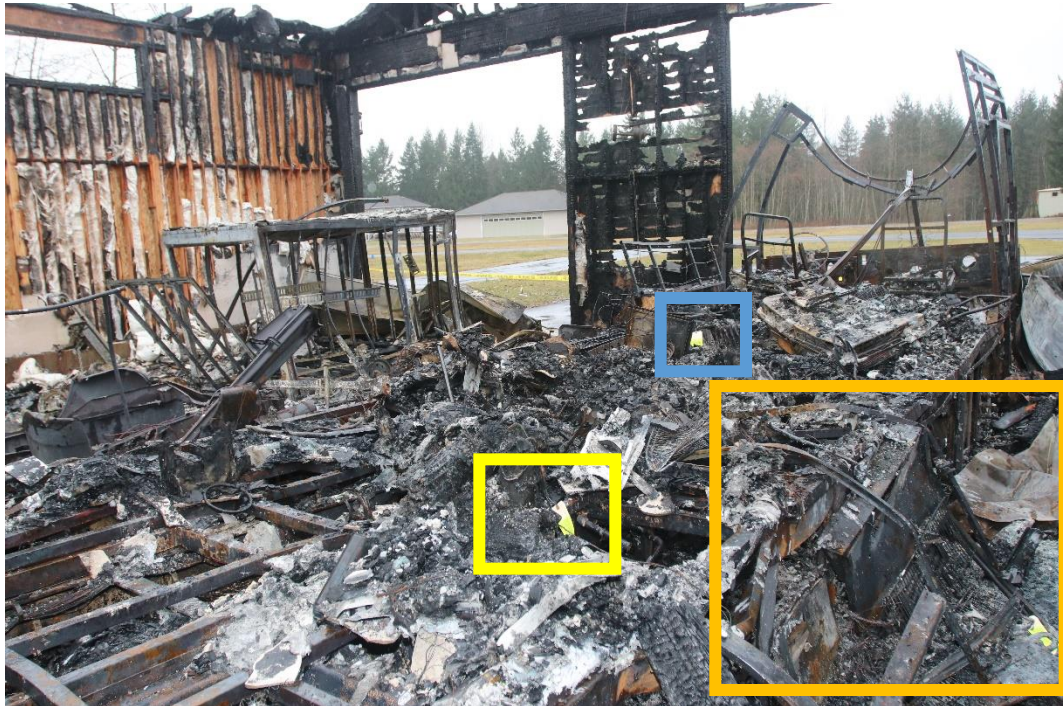
Photograph 3. 01-30-2021 SLR, IMG_0133: Area of origin with appliances identified. Yellow: dehumidifier, blue: portable heater and orange: refrigerator.

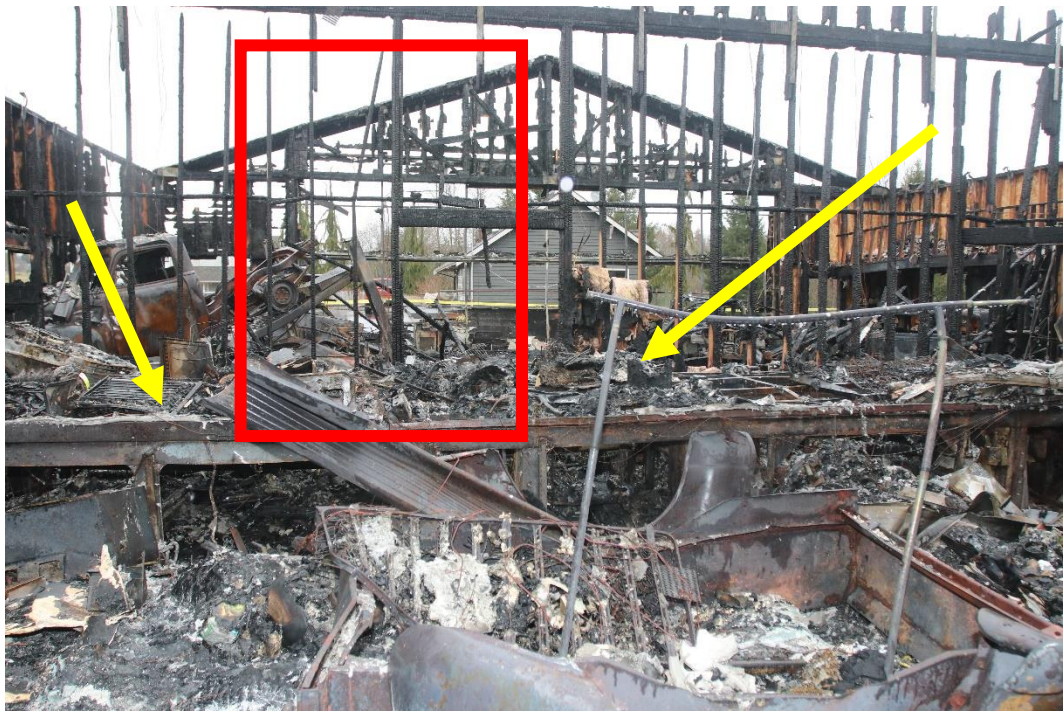
Photograph 4. 01-30-2021 SLR, IMG_0216: North interior wall of the garage adjacent to the motorhome. Origin area is detailed in the red box. The yellow arrows indicate the motorcoach location. Fire damage to the wood wall studs more pronounced in the area adjacent to the location of the refrigerator.

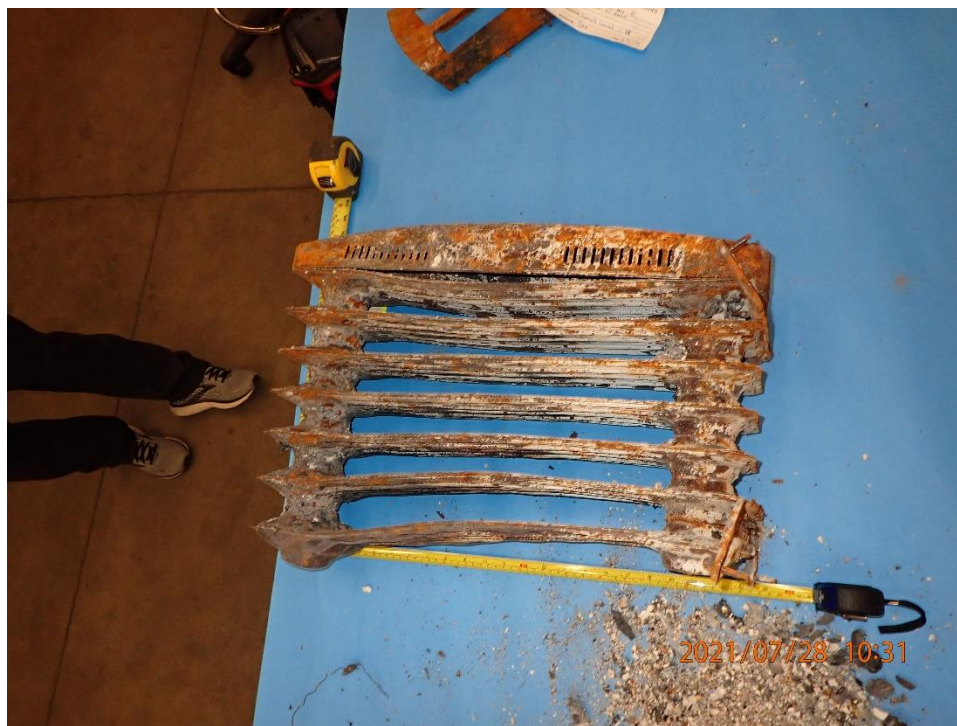
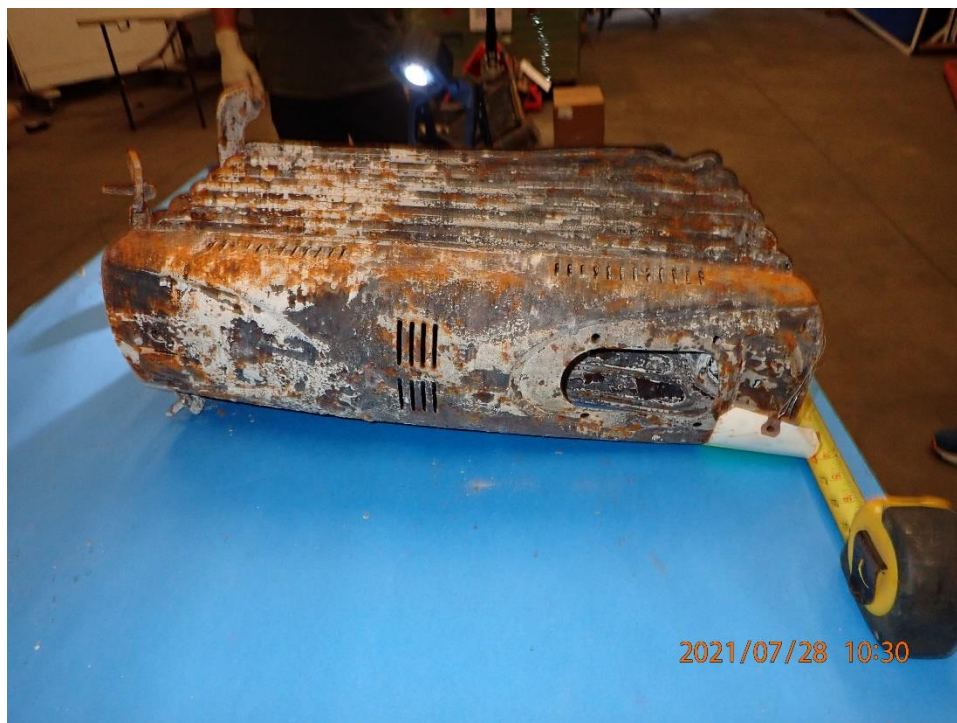
- 4.1.1 Visually examined and photographically documented the remnants of the oil radiant electric heater (Item #2) in its as-received condition, as seen in Figures 1 and 2.
- 4.1.2 Disassembled the heater's control panel, exposing components and electrical connections, shown in Figures 3.
- 4.1.3 Visually examined and photographically documented the heater's thermostat switch, level switch and heater element, as seen in Figures 4 and 5.

Figure 1. Item #2, oil filled electric radiant heater.

Figure 2. Item #2, control panel of oil filled electric radiant heater.

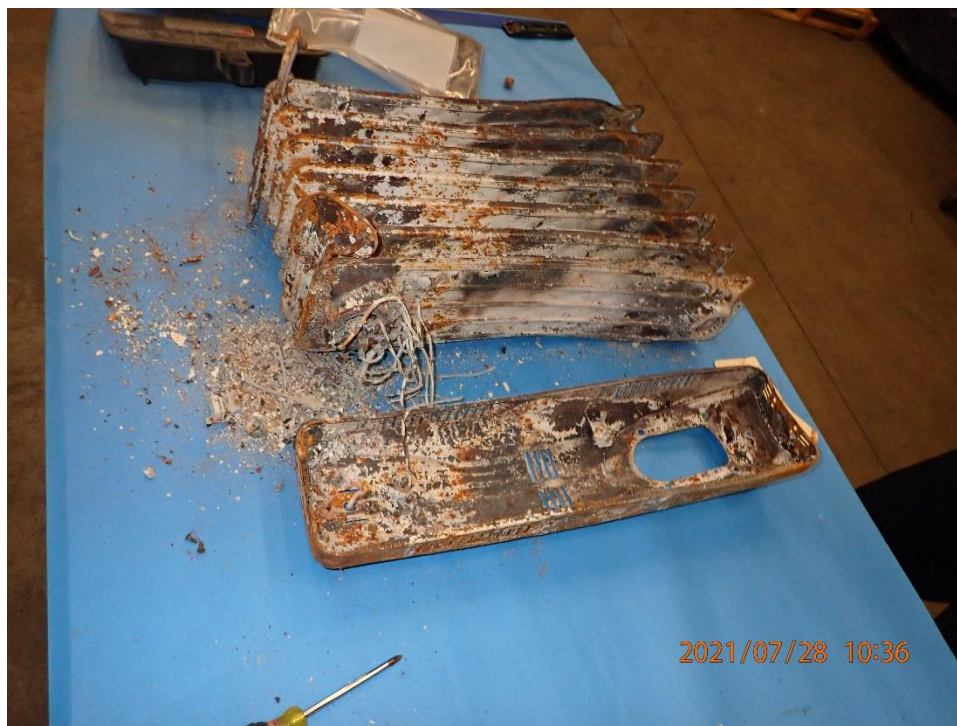
Figure 3. Item #2, control panel removed.

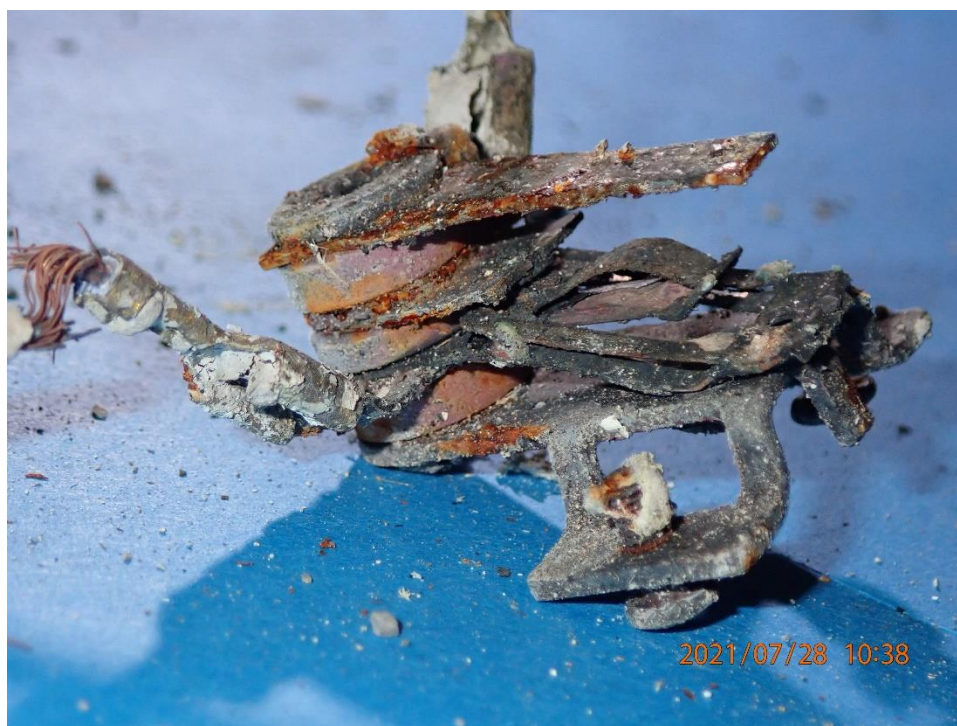
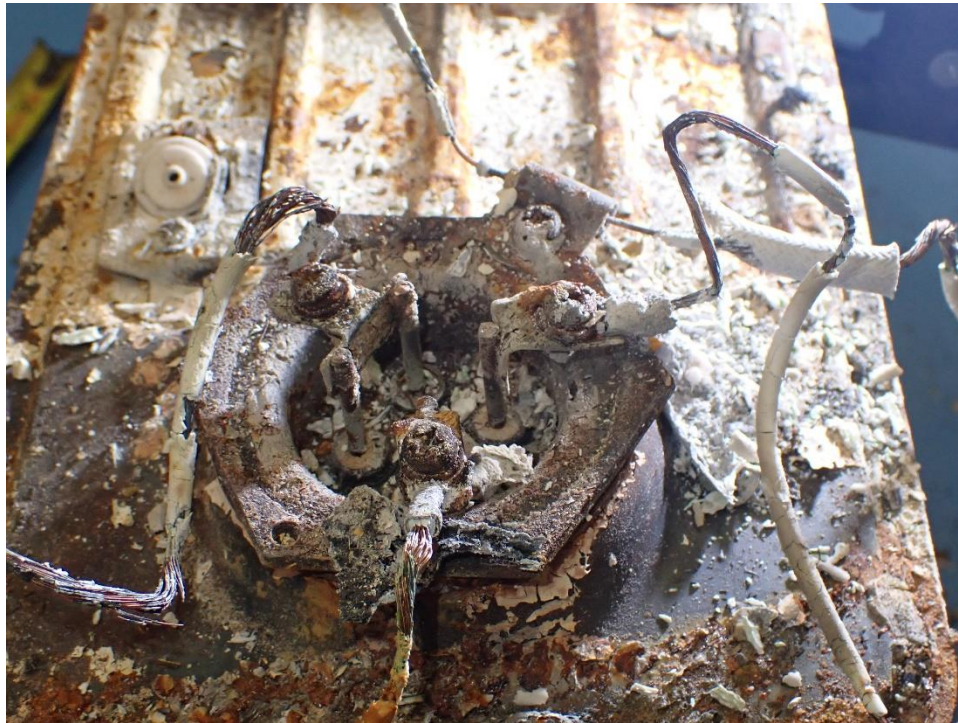
Figure 4. Item #2, thermostat.

Figure 5. Item #2, heater element connections.

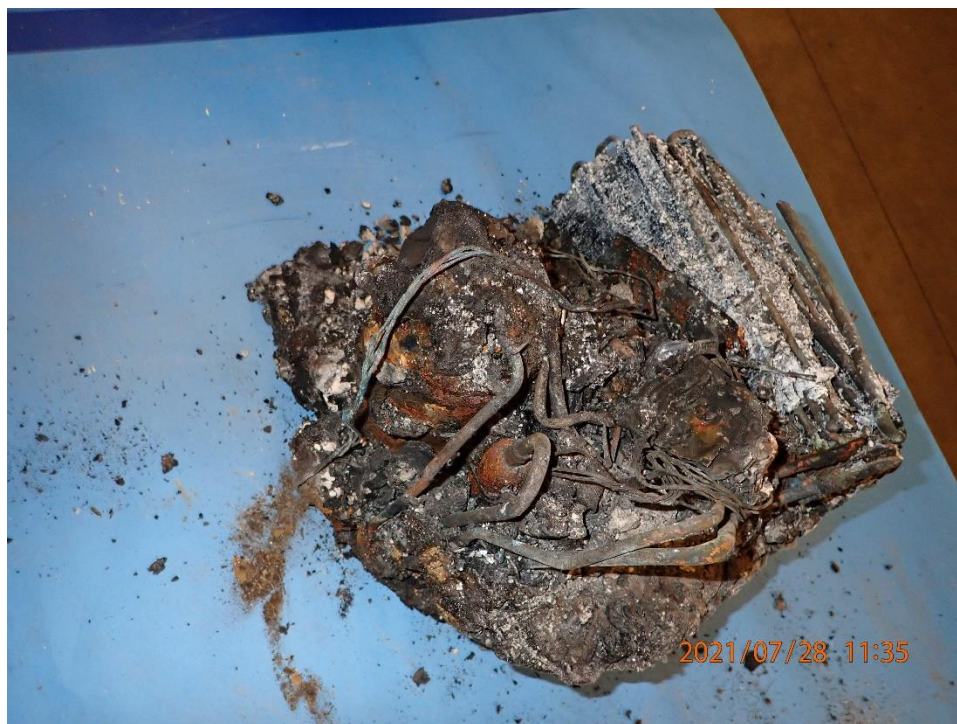
- 4.2.1** Visually examined and photographically documented the remnants of the dehumidifier (Item #3) in its as-received condition, as seen in Figure 6.
- 4.2.2** Disassembled the dehumidifier to visually examine and photographically document internal electrical components and wiring of the dehumidifier (Item #3), shown in Figures 6 and 7.
- 4.2.3** X-rayed the dehumidifier (Item #3) and circuit boards.
- 4.2.4** Visually examined and photographically documented the heater's thermostat switch, level switch and heater element, as seen in Figure 6.

Figure 6. Item #3, dehumidifier.

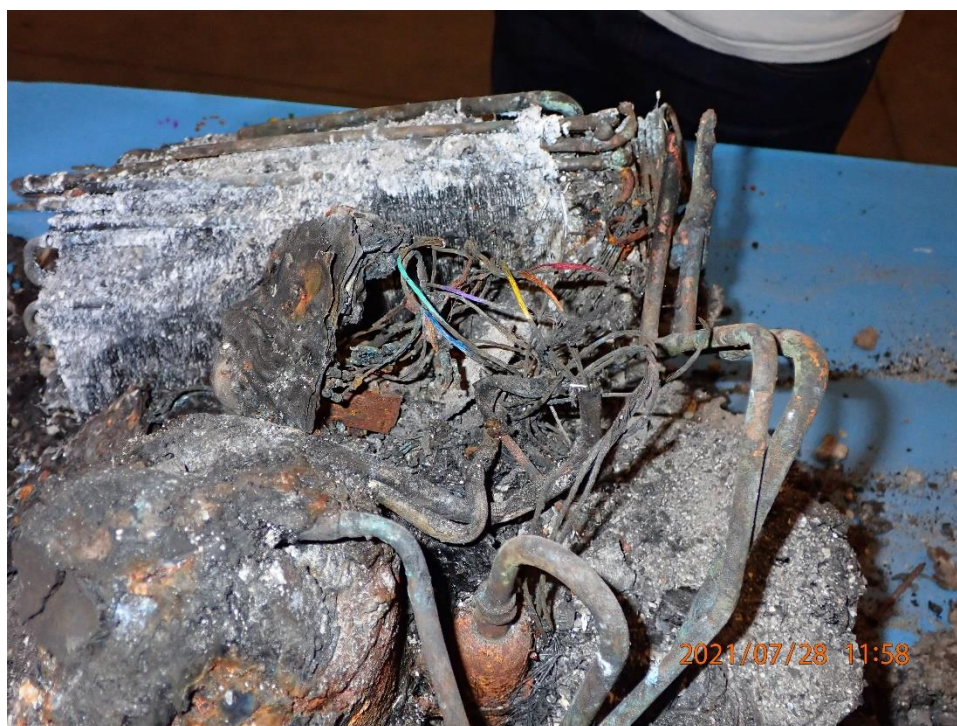
Figure 7. Item #3, dehumidifier internal wiring.

5.2.1 Basis: No electrical arcing was identified within the dehumidifier that would indicate that it was capable of starting the fire.

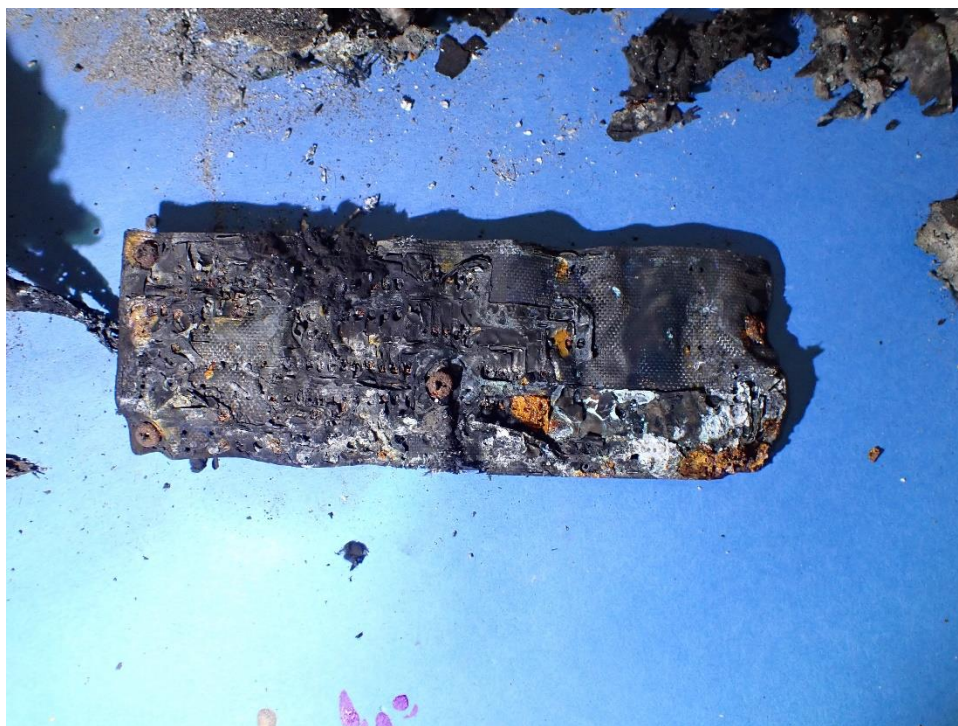
Figure 8. Item #3, circuit board.

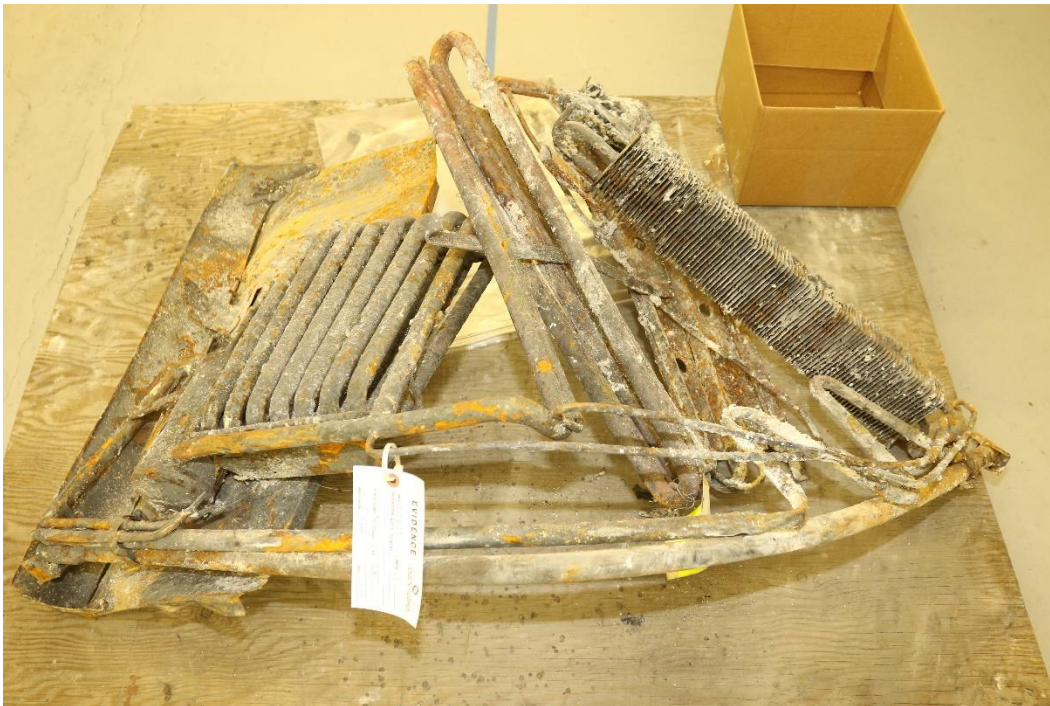
- 4.3.1** Jensen Hughes performed the following tasks on the Norcold refrigerator.
- 4.3.2** Visually examined and photographically documented the remnants of the subject Norcold refrigerator (Item #1) in their as-received condition, as seen in Figures 11 and 12.
- 4.3.3** Visually examined and photographically documented the boiler regions of the subject Norcold refrigerator in its as-received condition (Figures 13 through Figure 15).
- 4.3.4** Performed a leak test on the boiler/condenser system of the subject Norcold refrigerator, using air pressure and non-corrosive leak detection solutions (soap solution, alcohol) to determine the location of any perforations, shown in Figure 16. Figure 17 is a photograph

Figure 11. Item #1, described as “Norcold Refrigerator.”

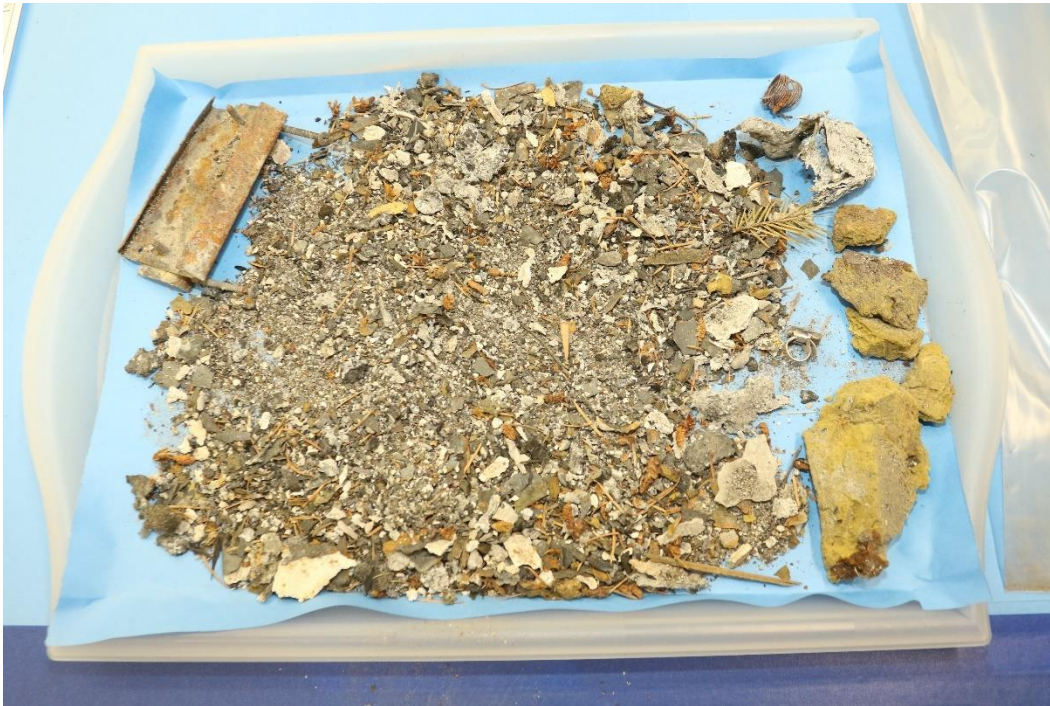
Figure 12. Item #1, described as “Norcold Fridge Components” which included various metallic parts, electronic components and conductors.

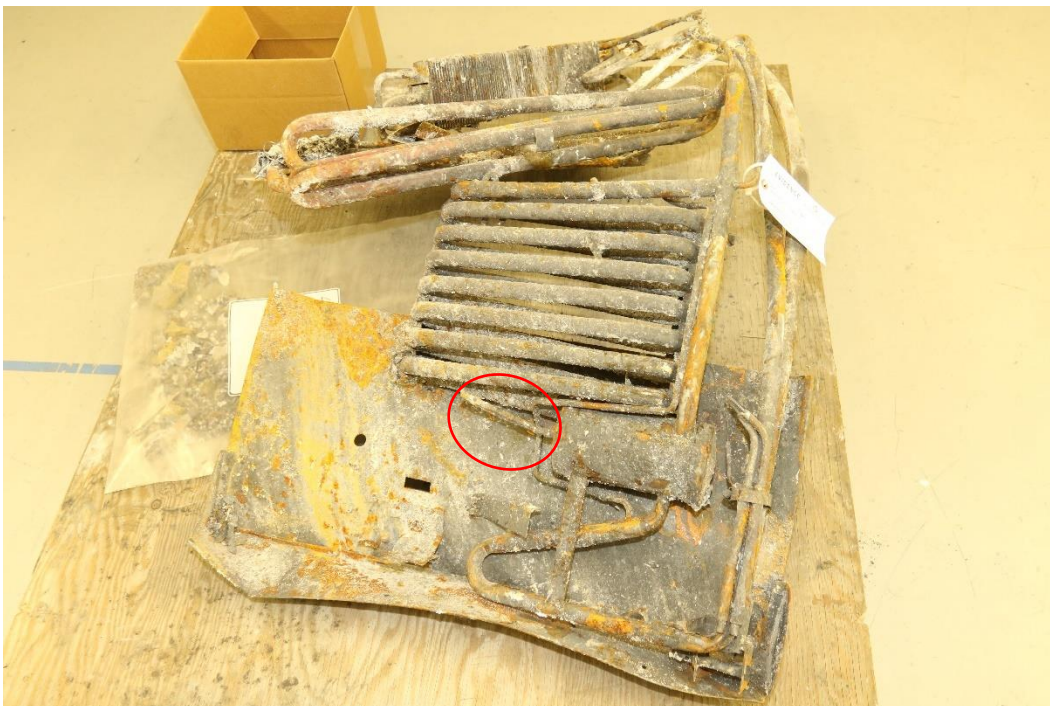
Figure 13. Item #1, the boiler assembly of the subject Norcold refrigerator. The pigtail coming off the absorber tank (circled in red) identified this refrigerator as being manufactured by Norcold.

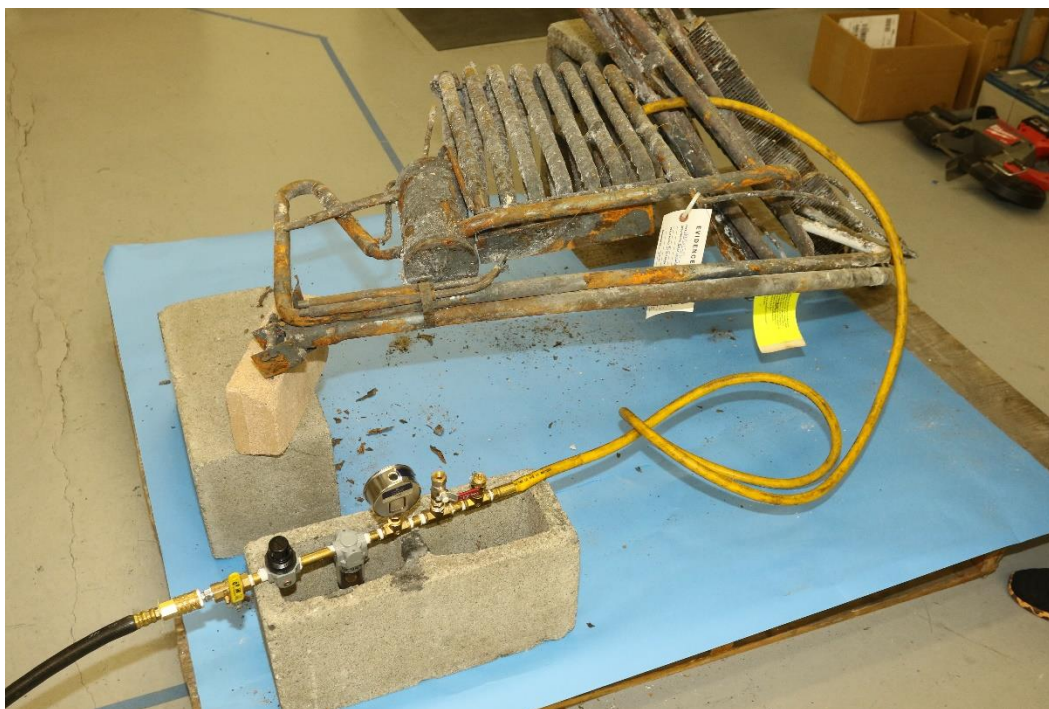
Figure 16. Item #1, pressure testing of boiler tube.

A leak test with air (a gas) was conducted during this investigation (Figure 16 and 17) in order to **identify** the post-fire perforation site and **only for this reason**. This leak test was not intended to try and mimic the pre-fire conditions of leaking refrigerant at the perforation site. The scientific reasons for this are multiple:

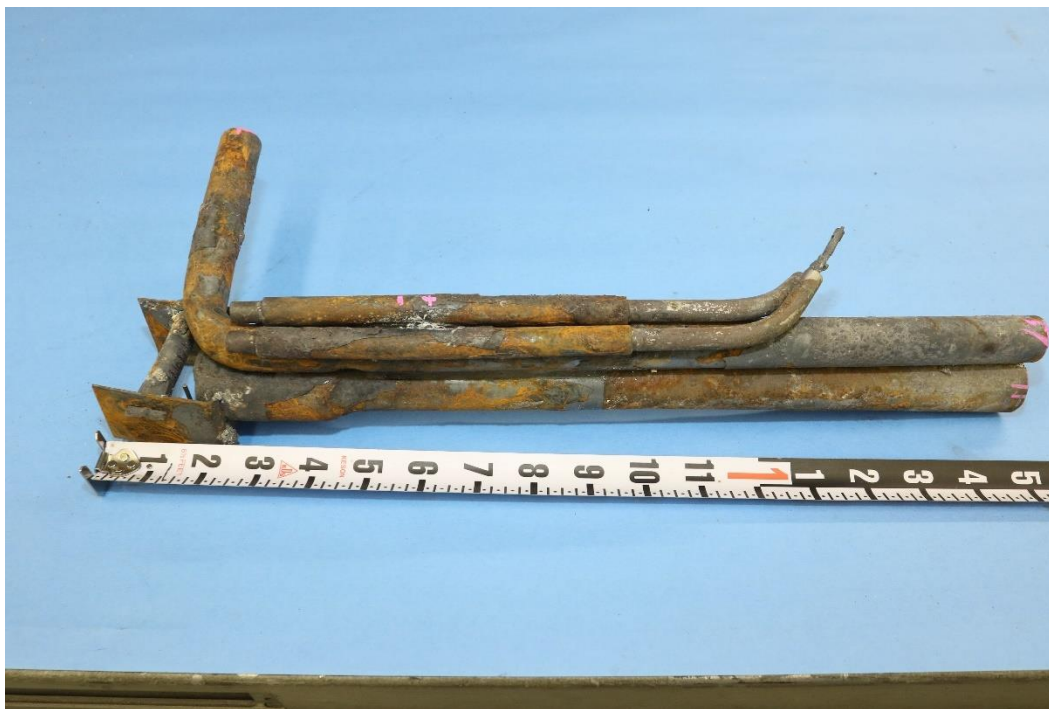
Figure 19. Item #1, photograph of the boiler assembly after being removed from the subject refrigerator.

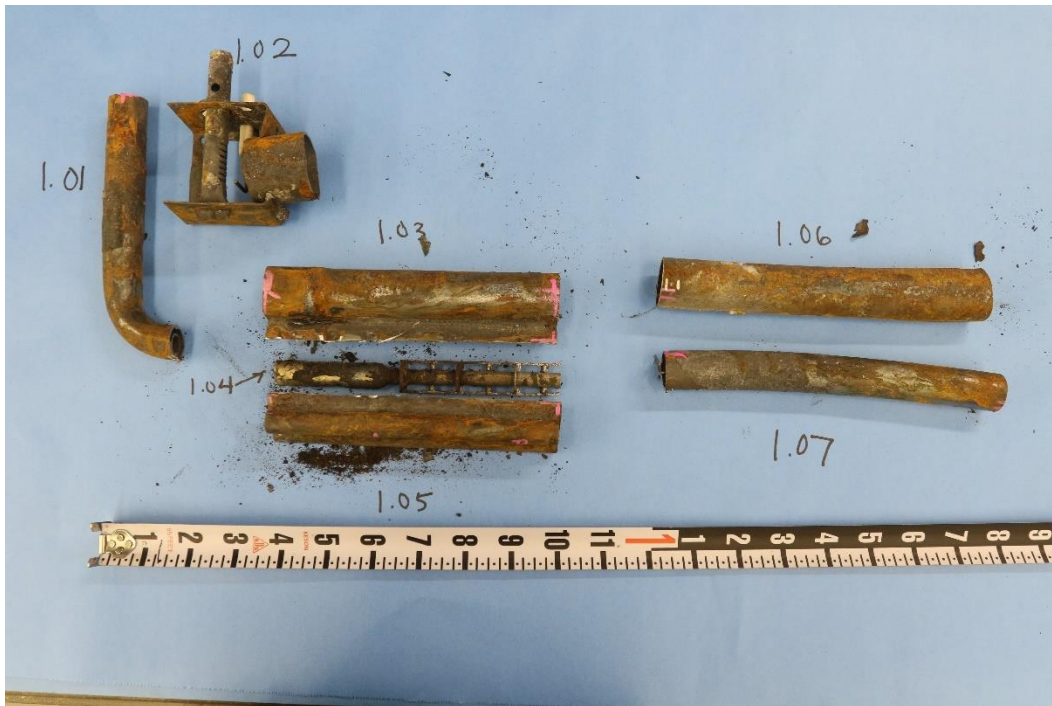
Figure 20. Photograph of Item #1.01, 1.02, 1.03, 1.04, 1.05, 1.06, and 1.07, after sectioning of Item #1.

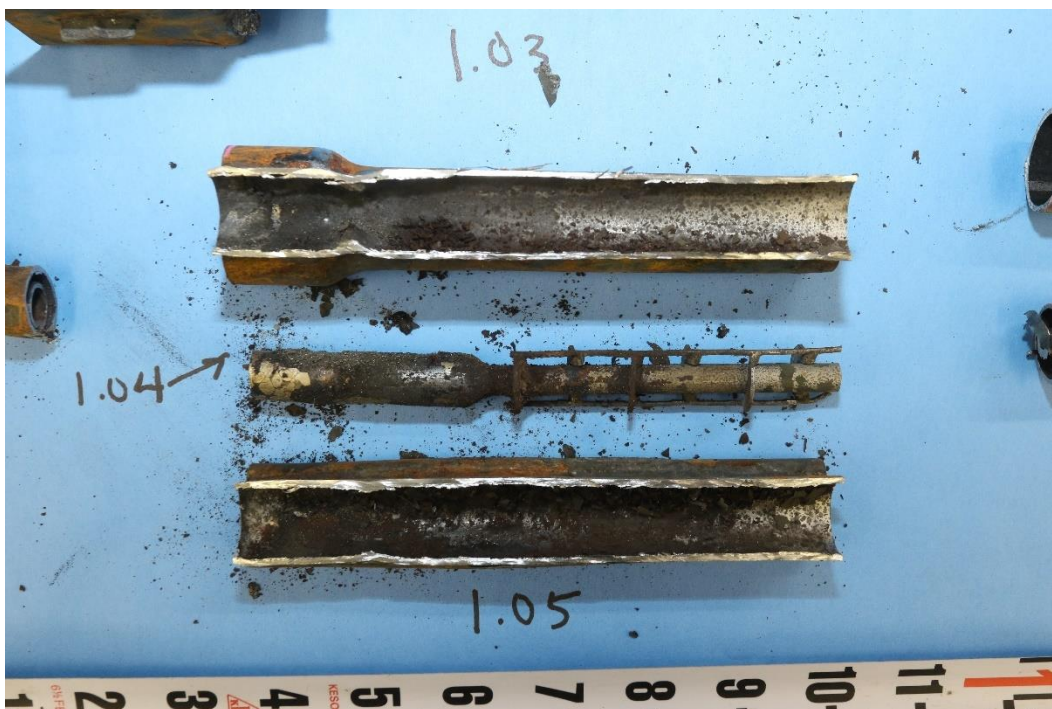
Figure 21. Item #1, photograph of the two halves of the boiler tube after sectioning.

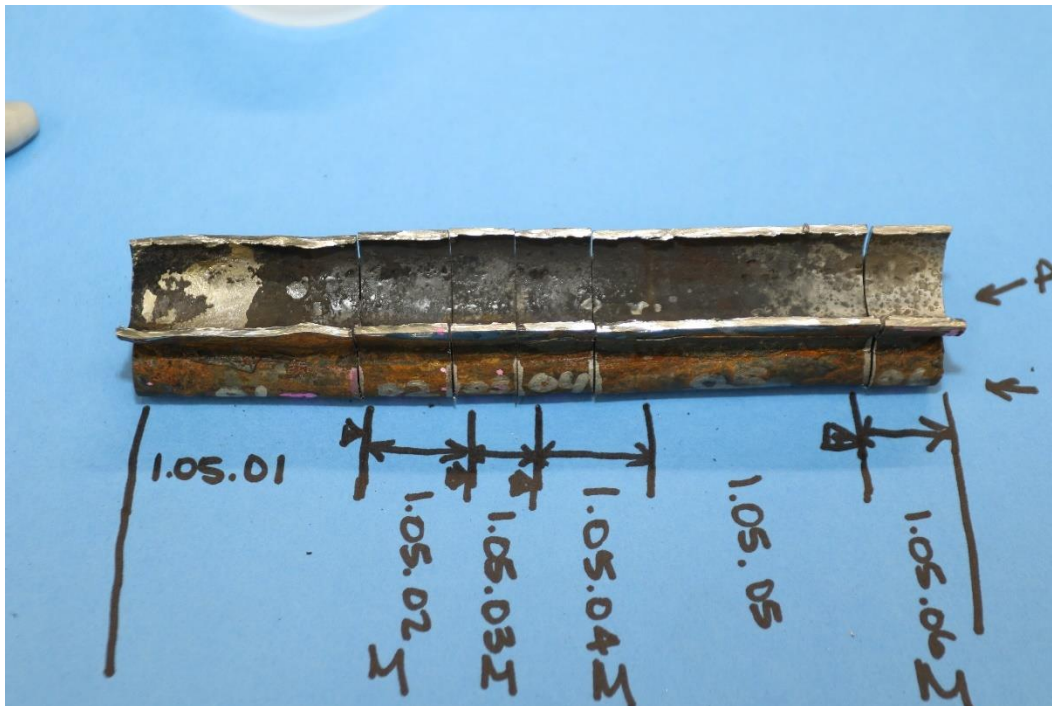
Figure 22. Item #1.05 and its associated sub-sections, photograph of the inner surface of the boiler tube at the perforation site.

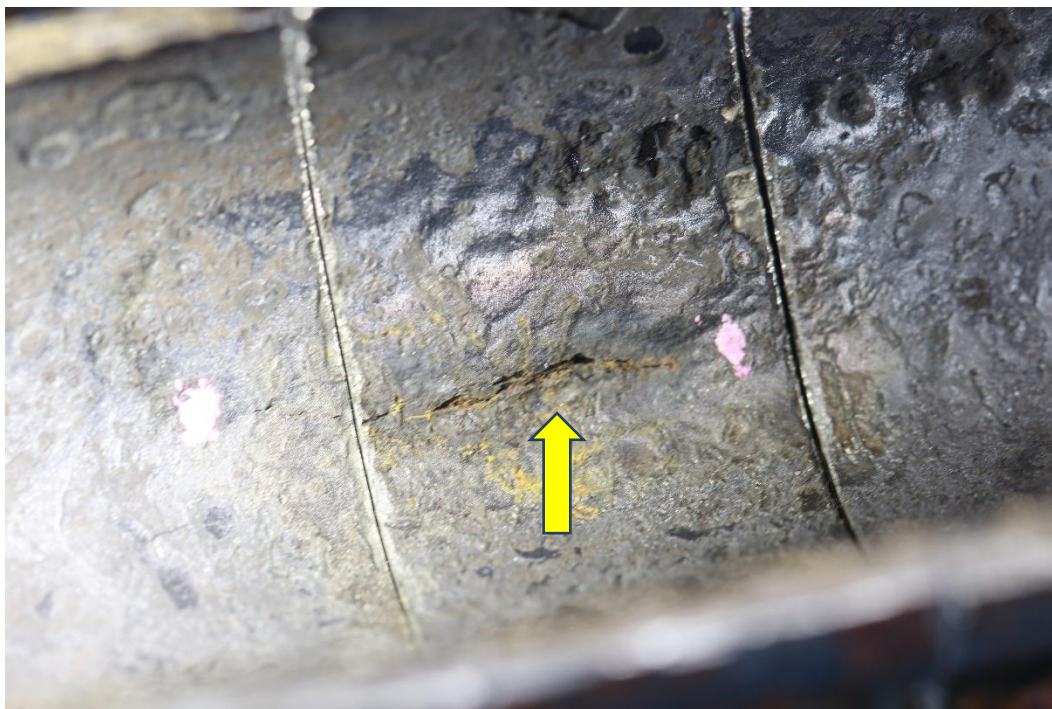
Figure 23. Item #1, enlarged view of tubing interior surface. The yellow arrow highlights an internal crack that progressed through the steel boiler tube and allowed flammable refrigerant to escape the boiler tubing.

5.4.1 Basis: The crack in the boiler tube was caused by an internal uniform corrosion process that deteriorated the thickness of the boiler tube wall. The boiler tube wall became so thin that the normal operating pressure was sufficient to create a small crack (perforation). An analysis using the material's yield strength revealed that an operating pressure in the range of 300 – 375 psi was likely sufficient to cause a crack.

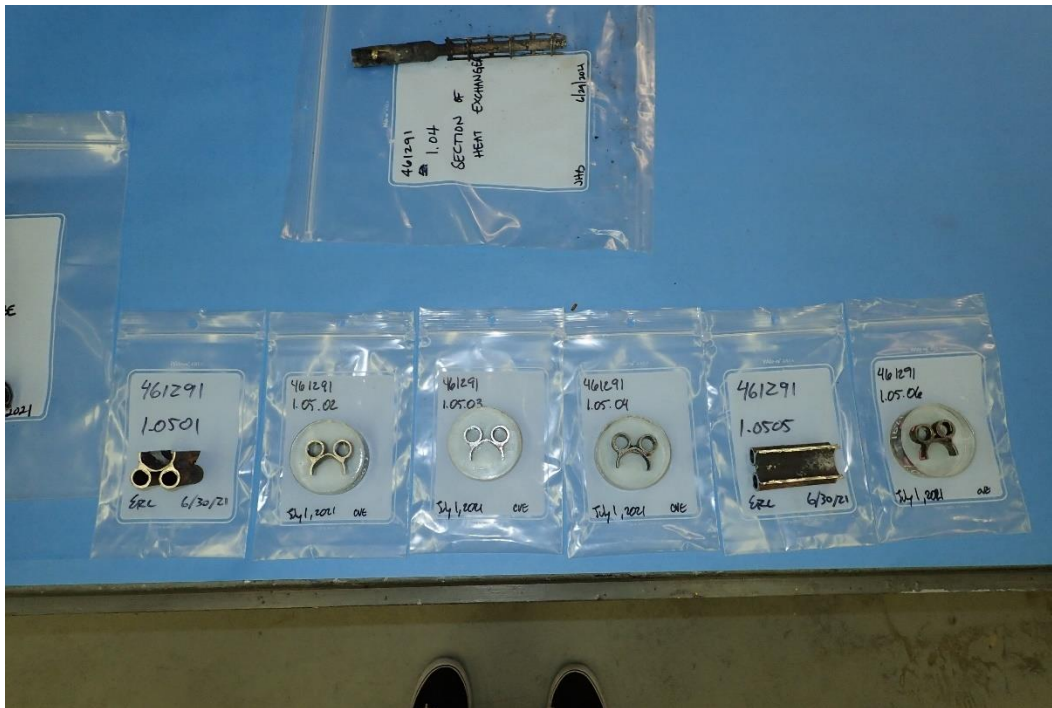
- 4.3.8** The mounted sample was ground and polished to a metallographic finish and etched with a 2% Nital solution to reveal grain structure (Figure 26).
- 4.3.9** Microscopically examined and documented the metallographic sample using a digital optical microscope, shown in Figures 27 and 28.

Figure 26. Tubing sections produced from Item #1.05 after cutting and mounting.

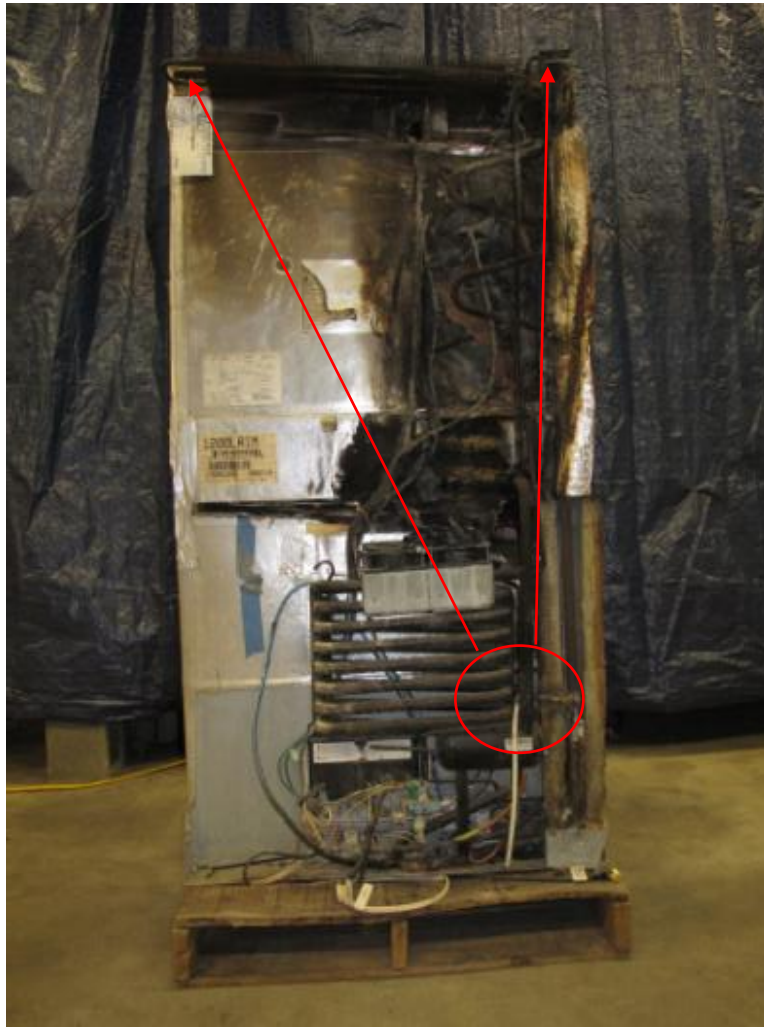
Figure 30. A photograph of the Baird refrigerator, Norcold 1200LRIM. The fire originated in the rear of the refrigerator and spread upward. The red circle shows the origin of the leak and subsequent fire, which was at the electric heating elements. The red lines show the direction and spread of the fire from the back of the refrigerator.
